**TWR-17546  
Vol VII**

# **Flight Set 360L007 (STS-33R) Field Joint Protection System, Thermal Protection System, and Systems Tunnel Components Final Report—Volume VII**

**September 1990**

This report documents the performance of the thermal protection system, field joint protection system, and systems tunnel components of flight set 360L007 as evaluated by postflight hardware inspection.

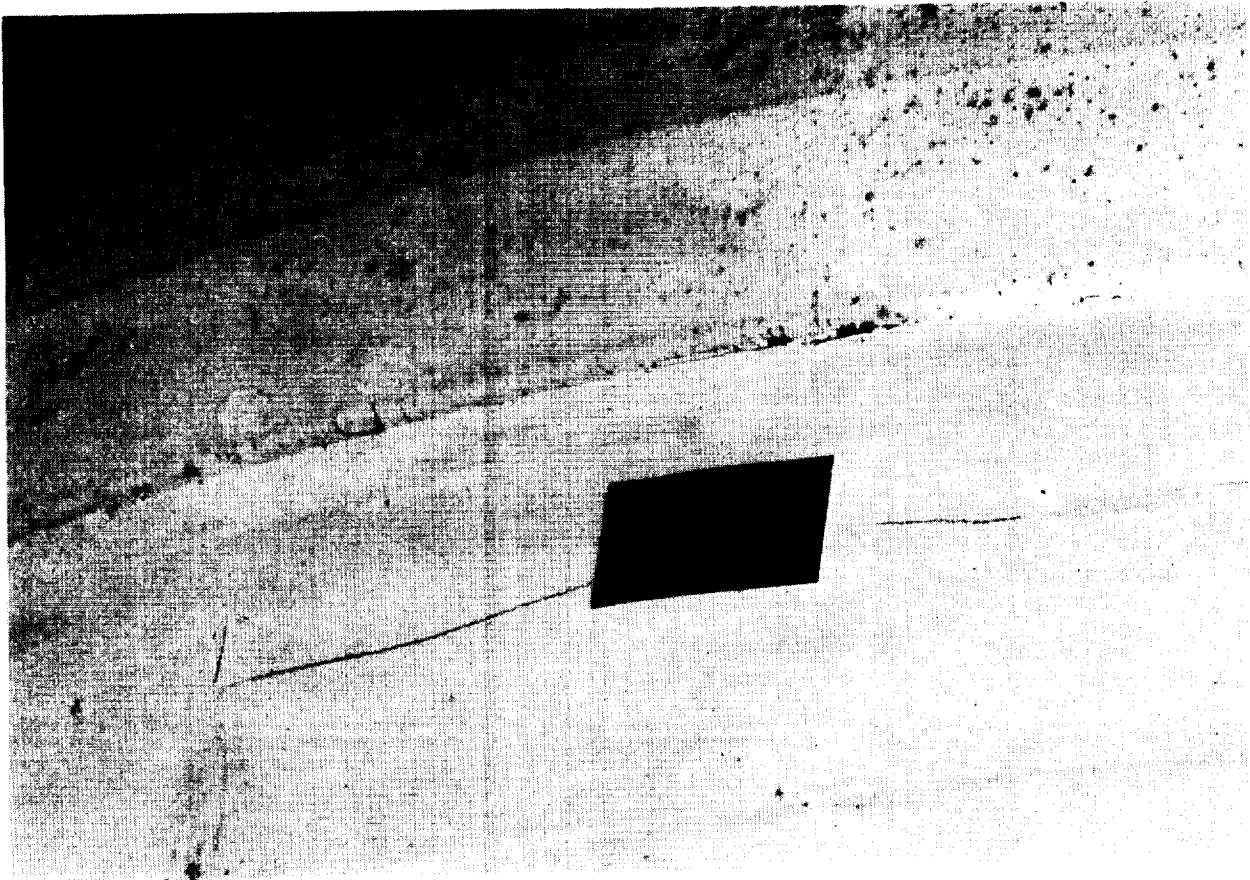
**Figure 3. Impact Marks on FJPS Cork  
(LH forward field joint)**

Numerous small cracks were observed on the forward edge of the LH forward FJPS cork between 240 and 260 deg (Figure 3). Impact marks were noted on each side of the affected area approximately 3 ft apart. Problem Report PV-6-146407 was written against these cracks (Appendix A). The cracks measured approximately 0.50 in. axially by less than 0.10 in. radially and were within the current material acceptance requirements. The impact marks were most likely caused by a parachute float line. A limit was added to the PEEL stating that cracks in the FJPS that meet current acceptance criteria are acceptable and should not be reported.

16. ITEM	17. PROBLEM DESCRIPTION  The left hand forward field joint forward edge from 240° to 260° exhibited two possible impact marks approximately 3 feet apart. Numerous small surface cracks were on the forward facing edge between the marks.

19. DESCRIPTION (ATTACH PFORS, FIGURES, PHOTOGRAPHS, ETC.) Numerous small cracks were observed on the forward edge of the forward field joint FJPS cork from 240 to 260 degrees. Impact marks were noted on each side of the affected area approximately 3 feet apart. The cracks measured approximately 0.50 inch axially by less than 0.10 inch radially.

20. HISTORY None. This is the first time that cracks of this type have been reported.			
21. CAUSE Cracks of this size meet the current material acceptance requirements. The impact marks were most likely caused by a parachute float line.

22. CORRECTIVE ACTION Add a limit to the PEEL stating that cracks in the FJPS that meet current acceptance criteria are acceptable and should not be reported.

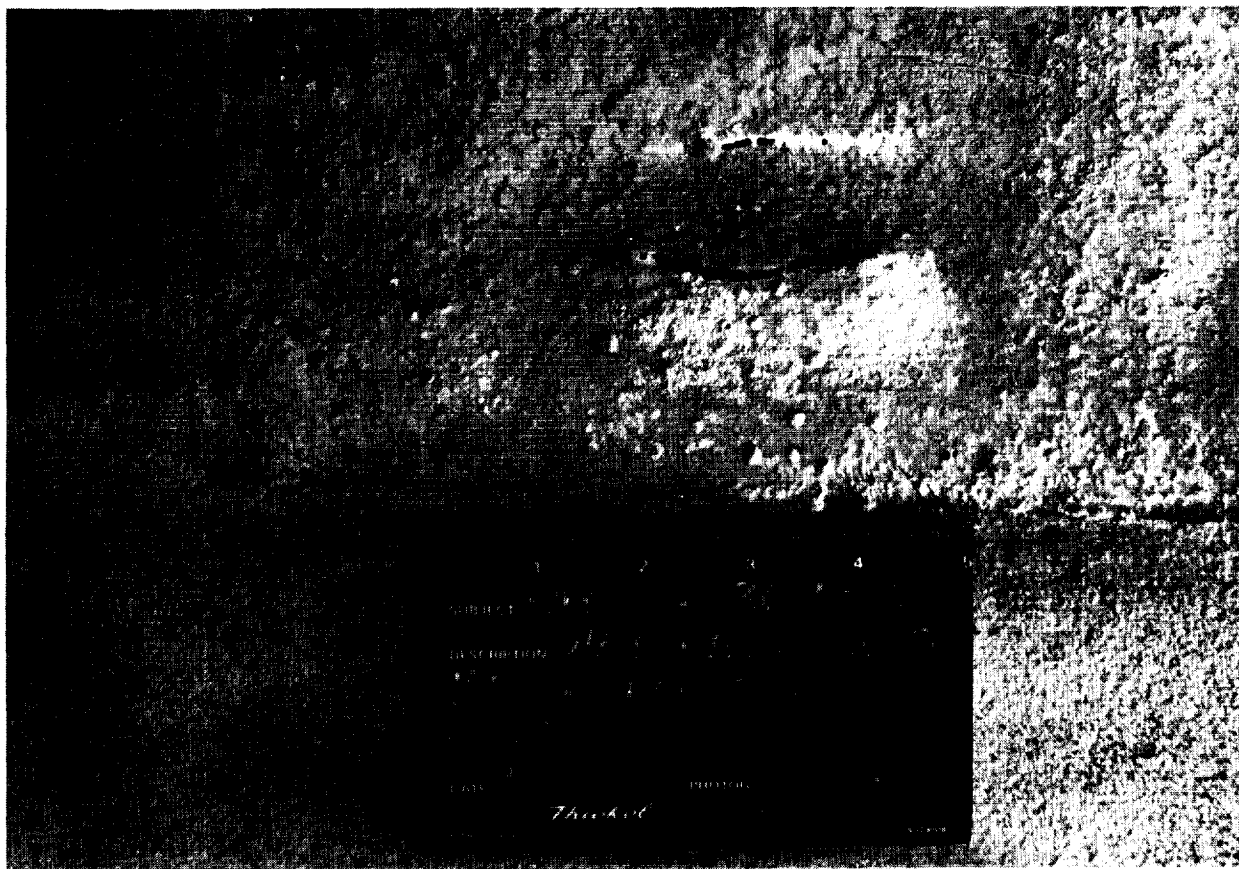
**Figure 4. Splits in K5NA Ablation Compound  
(LH aft field joint)**

Two circumferential cracks were found in the K5NA closeout over the trunnion/vent valve on the LH aft field joint at approximately 30 deg (Figure 4). The cracks were parallel (about 1.25 in. apart) and measured approximately 2.0 in. wide by less than 0.10 in. deep. The K5NA around the cracks was bulged out about 0.10 in. and could be depressed approximately 0.10 in. with hand pressure. Problem Report PV-6-146109 was written against these cracks (Appendix A). This condition was noted on a previous flight (360H005), and it was determined that a vacuum (due to vent valve operation) developed under the moisture seal during descent. This caused the moisture seal to be pulled down over the pin retainer band trunnion. The resulting stress in the K5NA induced a split. Since the condition occurred after SRB separation, there is no impact on flight safety and no corrective action was taken.

17. DESCRIPTION (ATTACH PFOR, FIGURES, PHOTOGRAPHS, ETC.) Two circumferential splits were found in the K5NA on the aft field joint at approximately 30 degrees measuring approximately 2.0 inches wide by 0.10 inch deep. The splits were about 1.25 inches apart. The K5NA around the splits was bulged out approximately 0.10 inch, was spongy, and could be depressed approximately 0.10 inch with hand pressure.

18. JUSTIFICATION OF CLASSIFICATION (POSTFIRE ENGINEERING EVALUATION LIMITS) The K5NA split occurred during descent. This condition was noted on a previous flight (360H005) and has no impact on flight schedule or safety. No new corrective action will be implemented.

19. CAUSE Vacuum under the moisture seal during descent caused the moisture seal to be pulled down over the pin retainer band trunnion. The resulting stress in the K5NA induced a split.

20. RECOMMENDED CORRECTIVE ACTION None.		21. ANOMALY APPROVAL SIGNATURE RPRB SECRETARY: /S/S. T. MUNSON DATE: 12/13/89	
		22. OBSERVATION/ANOMALY APPROVAL SIGNATURES PE: /S/R. S. JENSEN DATE: 12/20/89 PM: /S/G. L. STEPHENS DATE: 01/05/90
